Bridge Inspection Report

Inkerman Bridge

Road Name: *Queen Street*
Site ID: *03-124*
Structure Type: *Precast Box Beam*
Owner: *United Counties SDG*
Built: *1964*
Length: *20.5 m*
Width: *9.5 m*
Spans: *1*
Spans Arrange: *1 @ 19.5*
Feature Under: *Water*
Crossing: *North Branch of South Nation Riv*
Location: *Intersection of McIntosh Road & Queen Street (In*

Inspection Date: *July-20-21*
Inspector: *Harold Kleywegt, P.Eng.*
Assistant: *Kyle Davis, Eng Student*

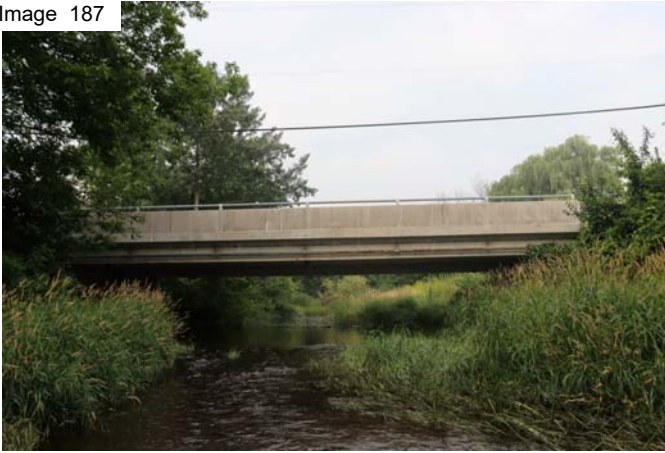
Image 187

East elevation

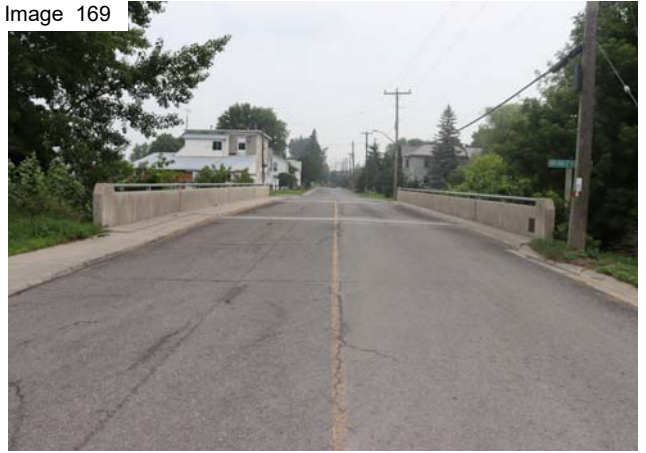
Image 169

South approach

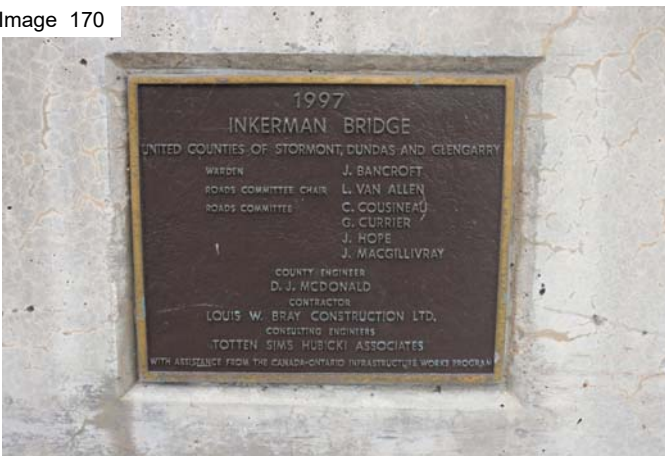
Image 170

Plaque SE

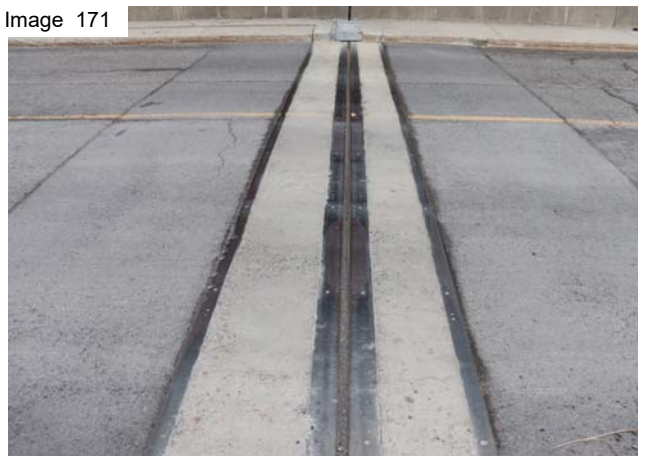
Image 171

X- Joint Conventional (2)	Defects 10.0%	Moderate Scaling/Abrasion	
Expansion Joints	Damage 3.0%	Moderate Plow Gouging, Minor End Dam Breakage	
Length: 9.5 m	Maintenance None		
Width:	Capital Rec. None		
Height:	<i>End dams have narrow transverse cracking micro-spalling & light scaling. Expansion joint armoring has moderate impact damage from plows. Seals are intact.</i>		
Scupper & Pipe (6)	Defects 60.0%	Major Corrosion	
Deck Drains	Damage 40.0%	Moderate Perforation, Moderate Section Loss	
Length:	Maintenance None		
Width:	Capital Rec. Replace in 1 year		Perf Def: Collateral Damage
Height:	<i>Deck drains are severely rusted and perforated. Drains penetrate 2nd girder from west & the east girder. Drainage impinging on girder soffits.</i>		
Conc Curb (1)	Defects 4.0%	Minor Scaling, Minor Abrasion	
Deck Safety Curb	Damage 0.0%		
Length: 37 m	Maintenance None		
Width: 0.68 m	Capital Rec. None		
Height: 0.15 m	<i>Curb on east side. Light scaling & abrasion on curb face, mostly good condition..</i>

South expansion joint

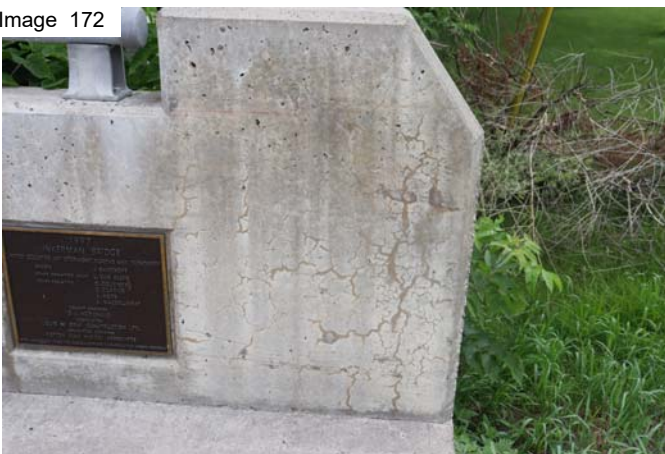
Image 172

SE end post with AAR

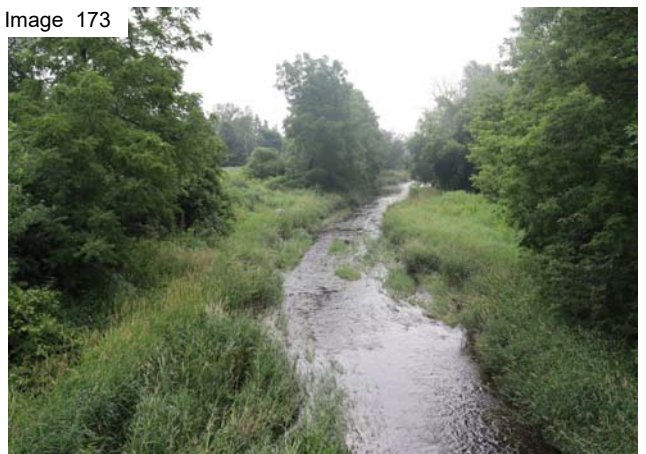
Image 173

East channel

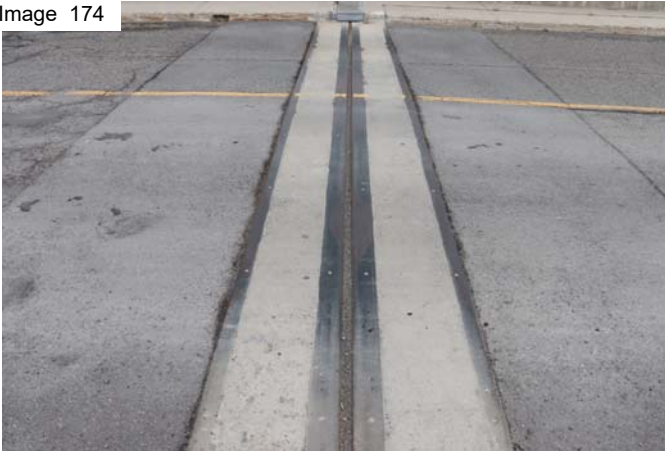
Image 174

North expansion joint

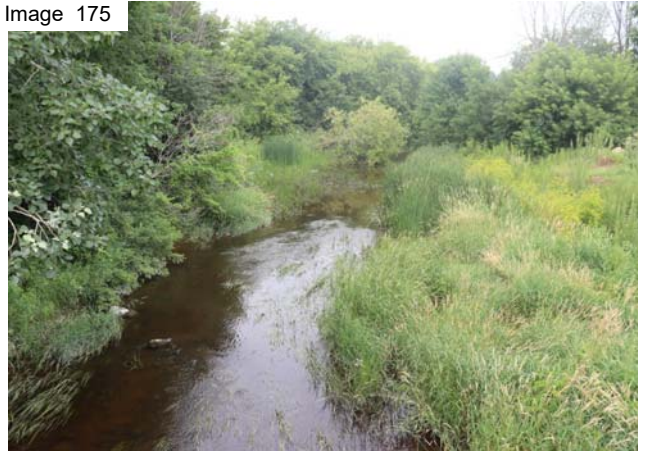
Image 175

West channel

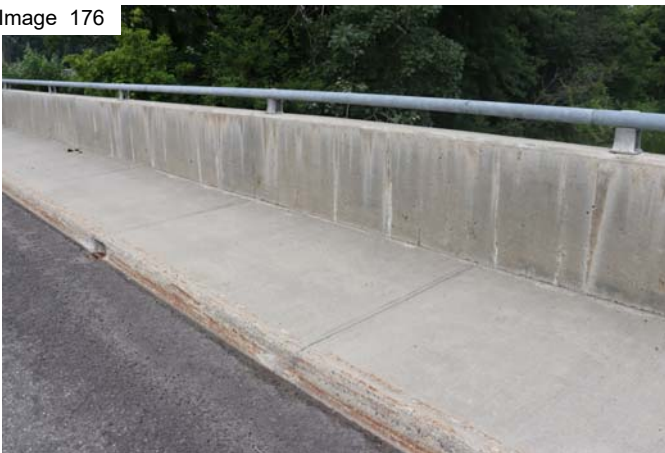
Image 176

Sidewalk (1)	Defects 10.0%	Minor Abrasion
Deck Sidewalk	Damage 1.0%	Minor Impact, Minor Cracking
Length: 37 m	Maintenance None	
Width: 1.65 m	Capital Rec. None	Perf Def: Settlement
Height: 0.15 m	<i>Sidewalk located on the west side. Sidewalk has minor abrasion on face. Vegetation growing through joint on approach sidewalk. Approach split sidewalk settling next to wing walls. Little change in 2021.</i>	
Single Pipe Hand Rail (2)	Defects 0.0%	
Railings	Damage 0.0%	
Length: 35.4 m	Maintenance None	
Width:	Capital Rec. None	
Height:	<i>Good condition.</i>	
RC Parapet (2)	Defects 5.0%	Minor AAR Cracking
Barrier / Parapet Walls	Damage 0.1%	Minor Delamination
Length: 37 m	Maintenance None	
Width:	Capital Rec. None	
Height: 0.85 m	<i>Parapet walls have areas of light AAR cracking. Small delamination on exterior in the NE quadrant. Utility located in west wall. Little change in 2021.</i>	
Voided Prestressed Box (9)	Defects 10.0%	Minor Formed Patches, Minor Rust Staining

West sidewalk and parapet wall

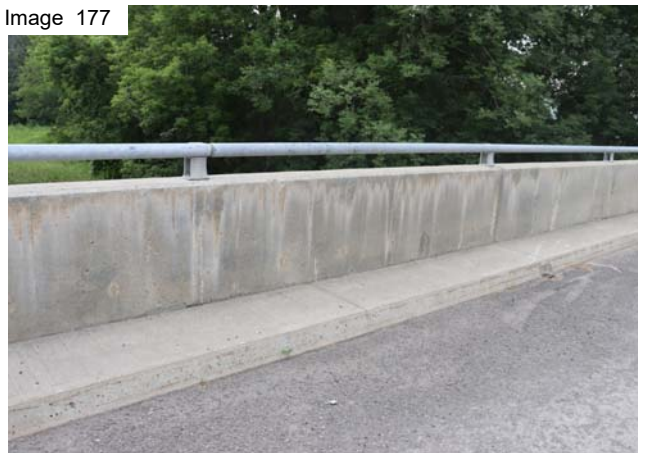
Image 177

East curb and parapet wall

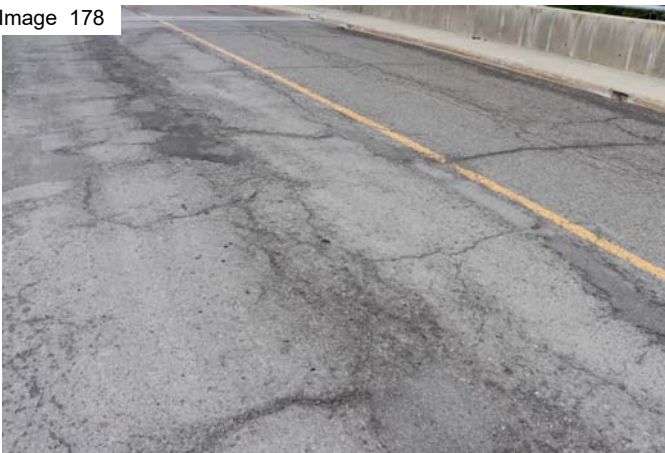
Image 178

Protected BSRC Deck (1)	Defects 0.0%		
Deck Surface	Damage 10.0%	Minor Delamination	
Length: 20 m	Maintenance None		Partial Inspection
Width: 9.5 m	Capital Rec. None		
Height:	<i>Asphalt hiding topping slab. Suspected leakage from construction joint in topping slab. Given the condition of asphalt on deck it is assumed damage below asphalt on deck top.</i>		
Asphalt Wear Surf (1)	Defects 25.0%	Moderate Ravelling	
Deck Wearing Surface	Damage 25.0%	Moderate Cracking, Moderate Potholing	
Length: 20 m	Maintenance None		
Width: 9.5 m	Capital Rec. Replace in 1 year		
Height:	<i>Asphalt on deck has numerous unsealed random cracks, potholes, & patches. Padding at approach slabs added in 2016.</i>		
Asphalt Wear Surf (2)	Defects 0.0%		
Appr Wearing Surface	Damage 20.0%	Moderate Cracking, Moderate Uneven Surface	
Length: 15 m	Maintenance None		
Width: 9 m	Capital Rec. None		
Height:	<i>Approach asphalt has moderate cracking. Expansion joints padded in 2016.</i>

Asphalt on deck (typical)

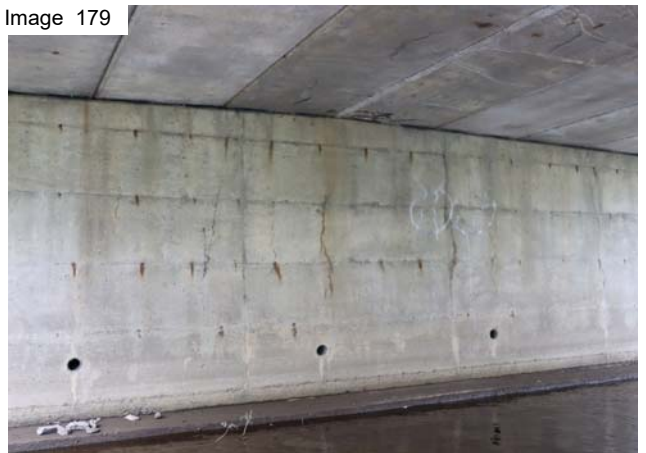
Image 179

South abutment

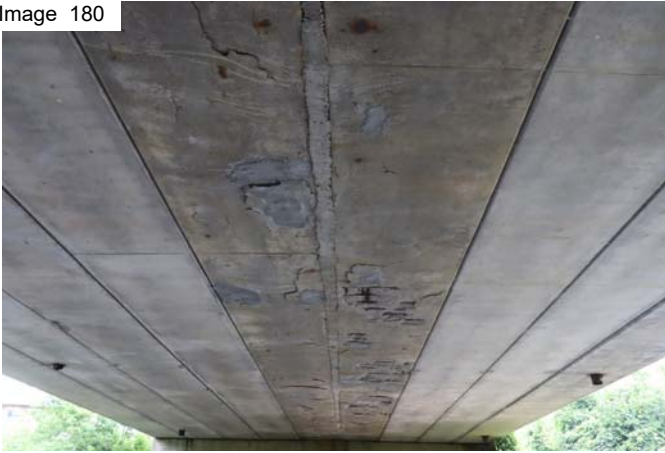
Soffit

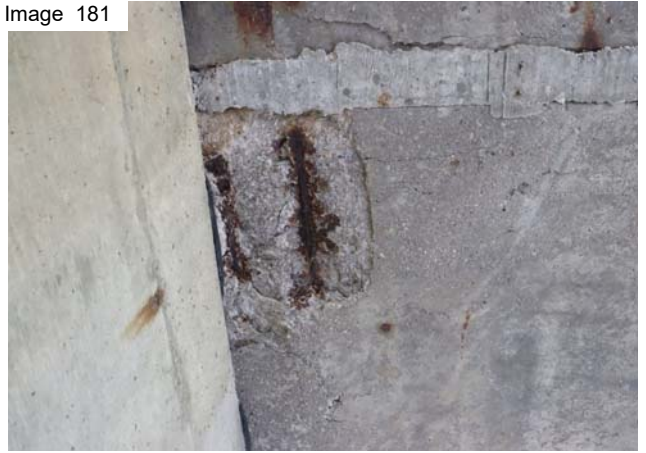
Image 181

Girders	Damage 25.0%	Critical Spalling, Major Delamination
Length: 20.5 m	Maintenance None	
Width: 1.2 m	Capital Rec. Replace in 2 years	
Height: 0.55 m	<i>Water has leaked through the joint between girders. Previous patches to girder bottoms have mostly delaminated or failed. Other girders starting to show delamination. Prestressing strands visible and corroded at one location. The girders appear to be too short or the abutments were not placed properly based on the gaps at the bridge seats. Two interior girders (5&6 of 9) exhibit the worst damage, exterior girders are in satisfactory condition. Utility attached to the east exterior.</i>	
RC Abutment Wall (2)	Defects 10.0%	Minor Rust Staining, Minor Scaling
Abutment Walls	Damage 1.0%	Minor Cracking
Length:	Maintenance None	
Width: 11.2 m	Capital Rec. None	
Height: 3 m	<i>Abutments are in good condition. Minor scaling & rust staining noted.</i>

Girder 5 south end spall

Superstructure Replacement \$1,000,000

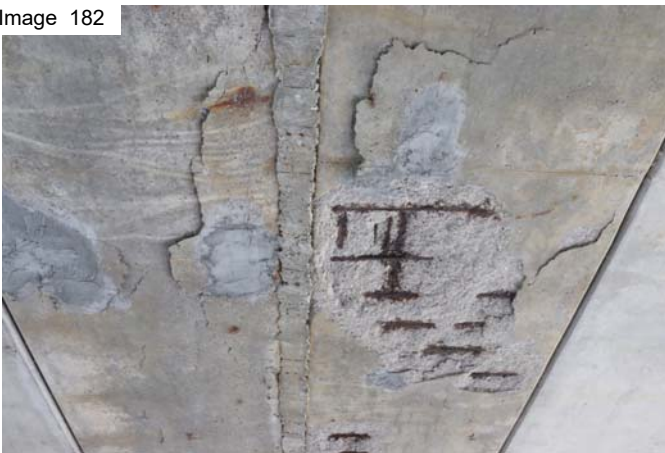
Image 182

Girders 5 and 6 spalling

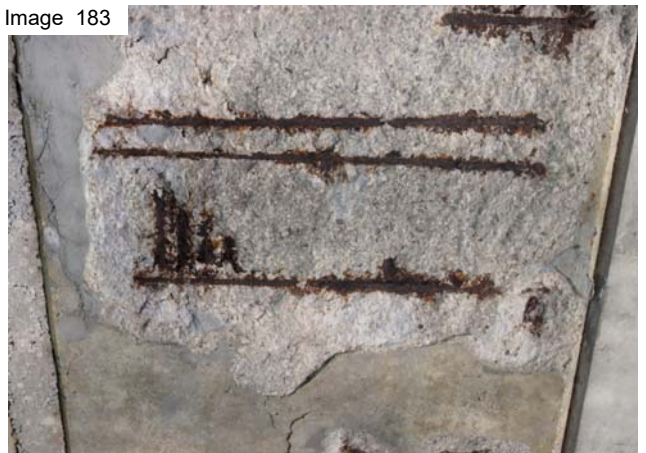
Image 183

Irreparable corrosion damage to prestressing strands of girders means full superstructure replacement is now required. Bridge may need to be load posted until such time as rehabilitation can be implemented.

Girder 6 spalling with prestressing strands visible

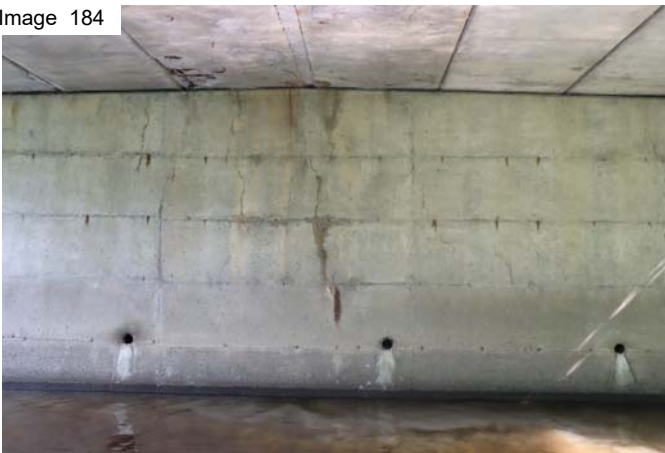
Image 184

North abutment

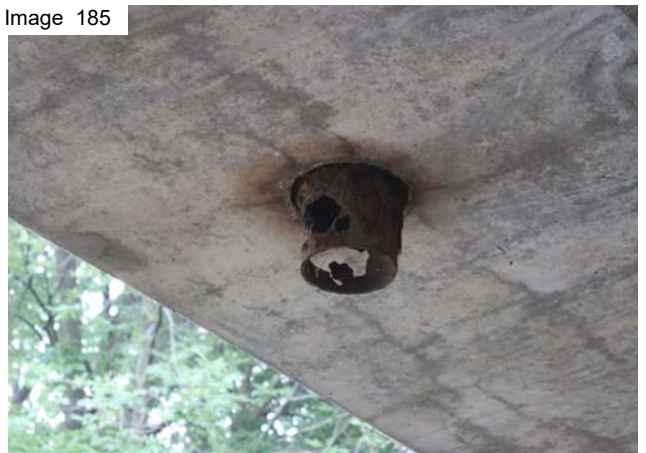
Image 185

East deck drain end (typical)

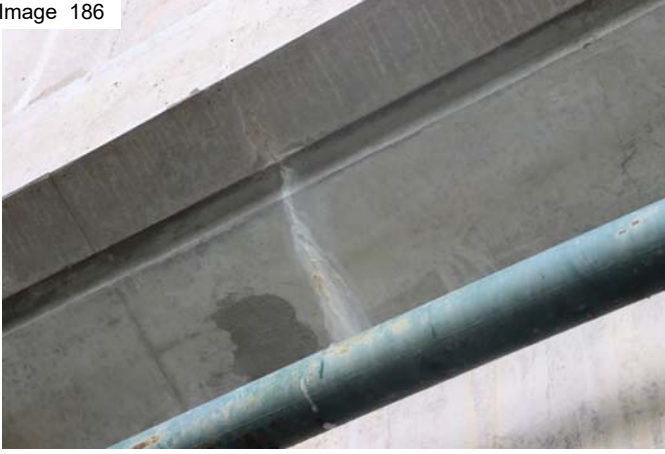
Image 186

Leaching along east fascia

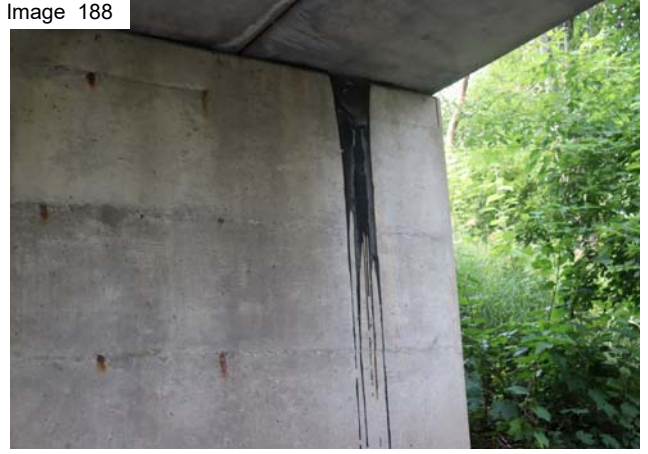
Image 188

SW abutment corner

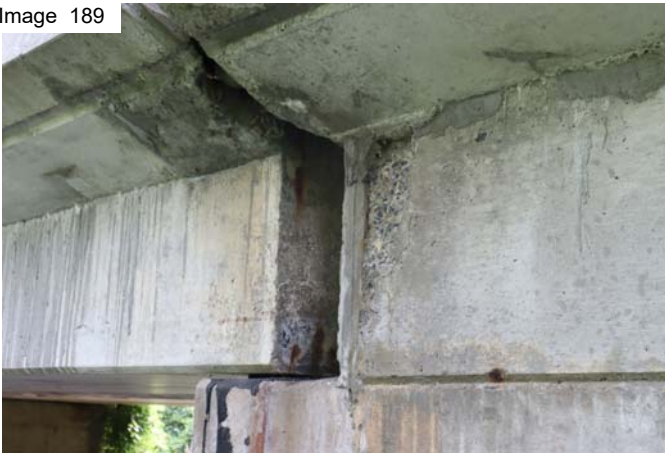
Image 189

Embankment (2) Embankments	Defects 0.0% Damage 0.0% Maintenance Remove Brush/Trees Capital Rec. None <i>Stable, vegetated. Trees & brush around wing walls should be cleared. No approach guide rail at bridge.</i>

SW wing wall

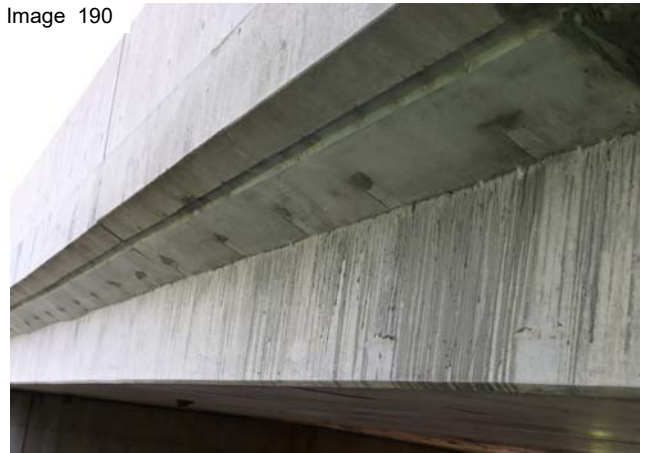
Image 190

West fascia
